# Cost-Effective Maintenance using Innovative Solutions

**The intrusive processes required to replace a large oil tank gaskets can take twice as long and be three times costlier than the Polywater leak repair option.**

An generation utility was preparing for overhauling its transformer fleet during a scheduled annual shutdown. However, oil leakage from the tank of a 260 MVA generating transformer (GT) gasket and bolts was a serious concern for its owner.

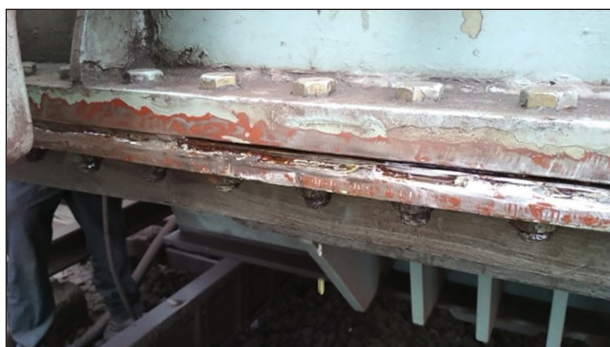
Active leaks can be detected as seepage accumulating on the surface of the transformer or as droplets of oil falling from the leak area. In the Surface Preparation photo (Step 1), droplets of oil can be seen dripping from the prepared surface. Once adjacent non-leaking areas have been sealed, active leakage points are now ready to be repaired.

Once the previously applied material was removed, the steel surface on which the PowerPatch was to be applied needed to be sanded and wiped clean. This step's goal was to remove paint and contamination that can reduce adhesion of PowerPatch to the repair

area. In addition, the sanding or grinding of the metal surface helps to increase the surface area to which the PowerPatch adheres, giving the seal greater strength. In many gasket repairs, the leak appears to arise from one point when the origin of the gasket leak may be quite far away. Polywater's experienced repair team, LeakXpert, used the surface preparation step to distinguish areas of active leaks containing true points of leakage from those that did not.
