# Cost-Effective Maintenance using Innovative Solutions

**The intrusive processes required to replace a large oil tank gaskets can take twice as long and be three times costlier than the Polywater leak repair option.**

An generation utility was preparing for overhauling its transformer fleet during a scheduled annual shutdown. However, oil leakage from the tank of a 260 MVA generating transformer (GT) gasket and bolts was a serious concern for its owner.

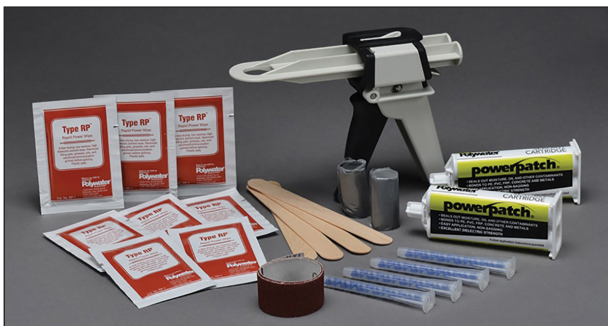
In previous years, the transformer owner had used its own repair teams to tighten the bolts on the cover of the transformer to stem the oil flow. This had been done enough times that further tightening would have been counter-productive due to the potential ageing of the gasket. The customer had also used its repair team and outside contractors in past shutdowns to stop oil leakage. Different sealant materials were used for these repairs, but they did not perform well with active gasket leaks. The most recent oil leak repair material had started to leak heavily from multiple points, so a more effective repair material needed to be identified and approved.

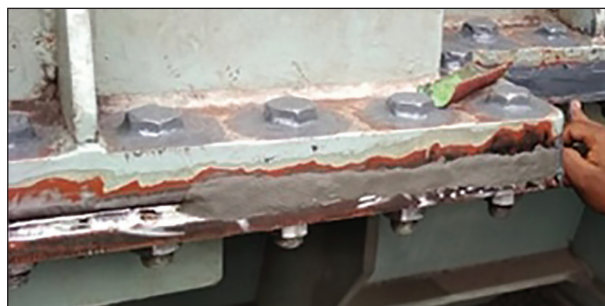
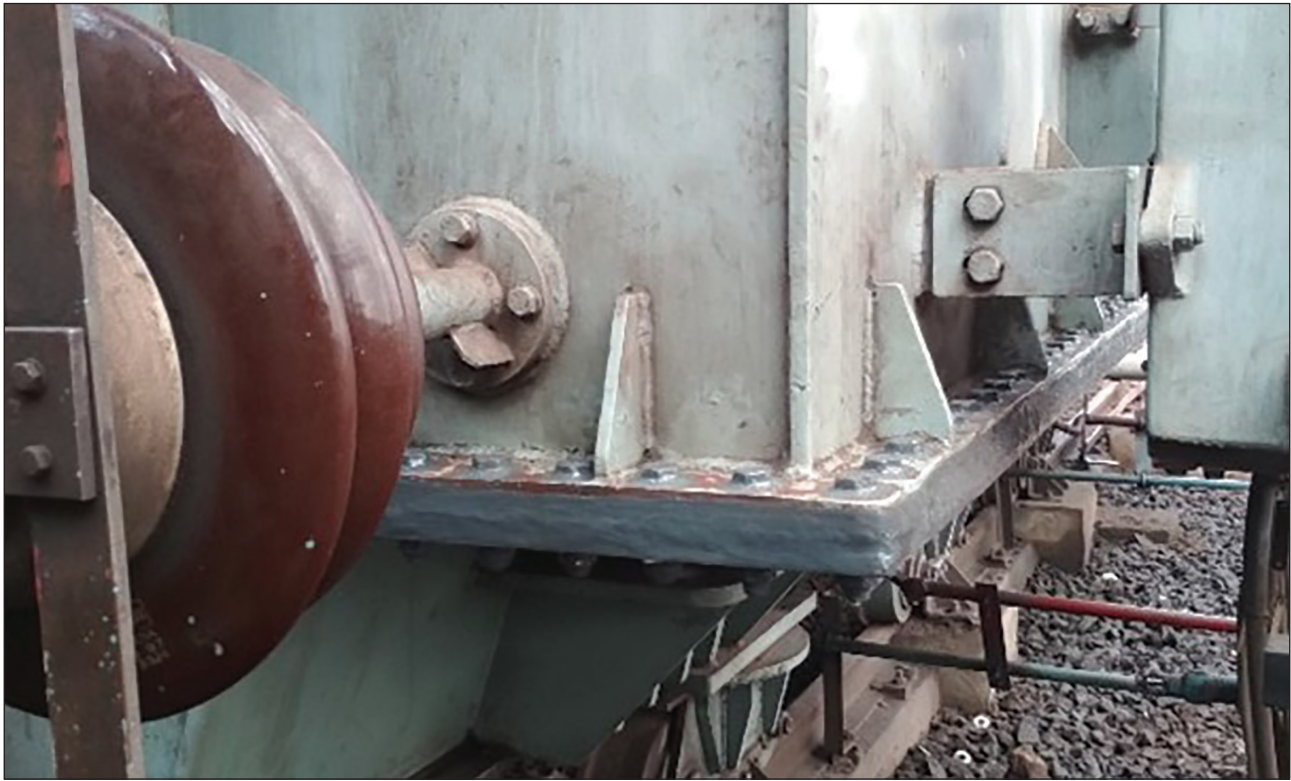
Active leaks can be detected as seepage accumulating on the surface of the transformer or as droplets of oil falling from the leak area. In the Surface Preparation photo (Step 1), droplets of oil can be seen dripping from the prepared surface. Once adjacent non-leaking areas have been sealed, active leakage points are now ready to be repaired.

Sealing active leaks takes an additional step. This step aims to stop the active leak to allow for proper surface preparation and the application of the permanent PowerPatch material as described in the previous section. After abrasion and cleaning the leak area, a fast-curing putty is applied directly over the active leak and held under hand-pressure until it hardens. This takes typically 5-7 minutes, depending on temperature. Once hardened, surface preparation is done again, including sanding, grinding and cleaning around the putty. When properly prepared and cleaned, the permanent PowerPatch resin is applied directly over the putty and then spread one (1) cm (0.4 in.) beyond the edges of the putty at all points. When the PowerPatch resin hardens and cures, it forms a strong and durable seal.

The repair of an active leak can be difficult, especially for inexperienced repair teams. The LeakXpert team's extensive experience using PowerPatch putty and the permanent PowerPatch sealant to stop active leaks allowed for the GT gasket to be sealed quickly and efficiently. More importantly, the PowerPatch offered an un-intrusive alternative to traditional gasket replacement that required less time and money.
